A Programmatic Approach to On Condition Maintenance

NAVAIR

H46FST

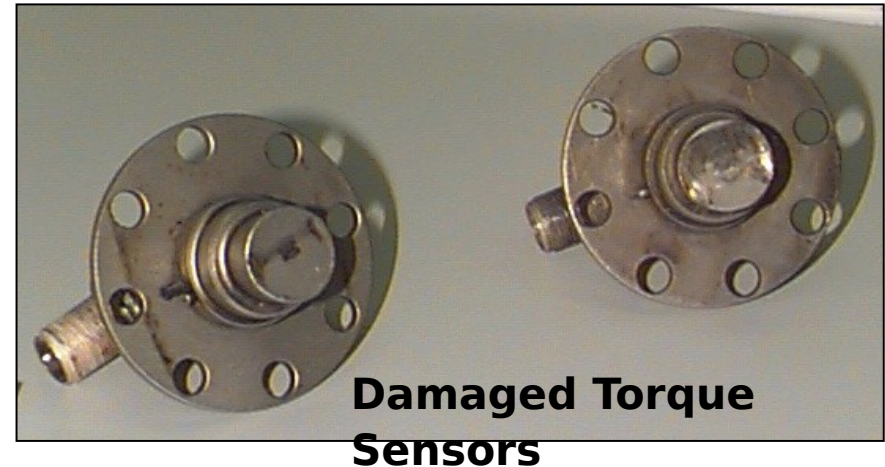
High Speed Shaft Resonance

- Damaged torque sensors
- Erroneous torque readings

- Spline wear allowing resonance in HSS
- HSS resonance undetected with previous equipment
- Pilots troubleshooting by throttling the engine back and causing resonance
- Spectral analysis equipment can detect resonance

- Inspection of spline wear implemented
- Check for resonance with use of narrowband equipment when erratic torque readings reported
- Pilots instructed to operate at 100% Nf/Nr

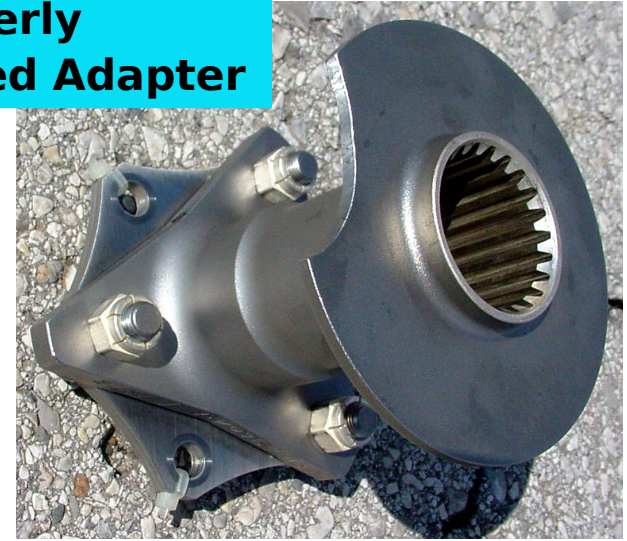
Improperly Balanced Adapter

High Speed Shaft Adapter Imbalance

- Periodic vibration checks expanded to in flight regimes revealed HSS levels as high as 26 g's
- Balancing procedures at vendor and depot facilities found to be inadequate

- Balance machines updated and match set balancing implemented

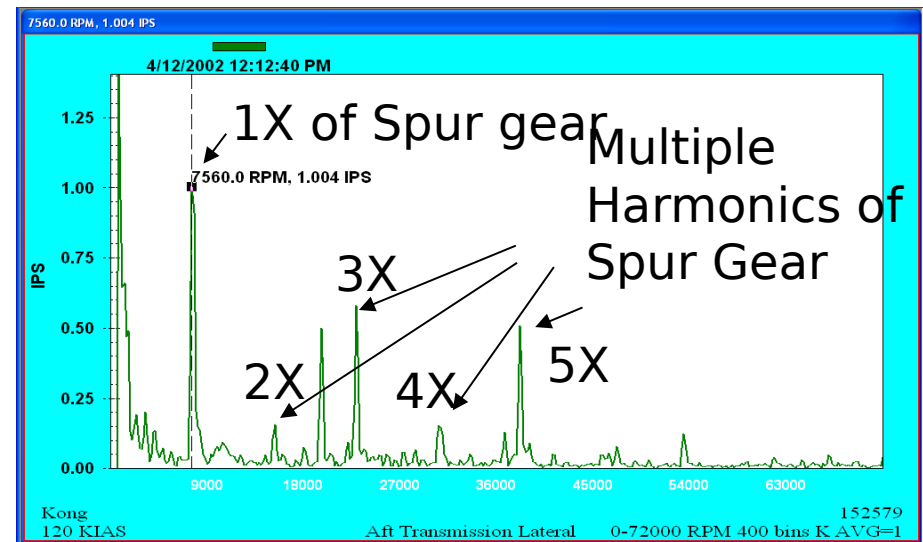
AFT Transmission Life Extensions

- High time of Aft Xmsn is 900 hours
- Life extensions granted without data
- Untimely failures resulted

- Failures can be detected by vibration analysis

- Mandatory submittal of vibration data required for life extensions
- If able to eliminate resonance the Xmsn may be able to extend to 1800 hours

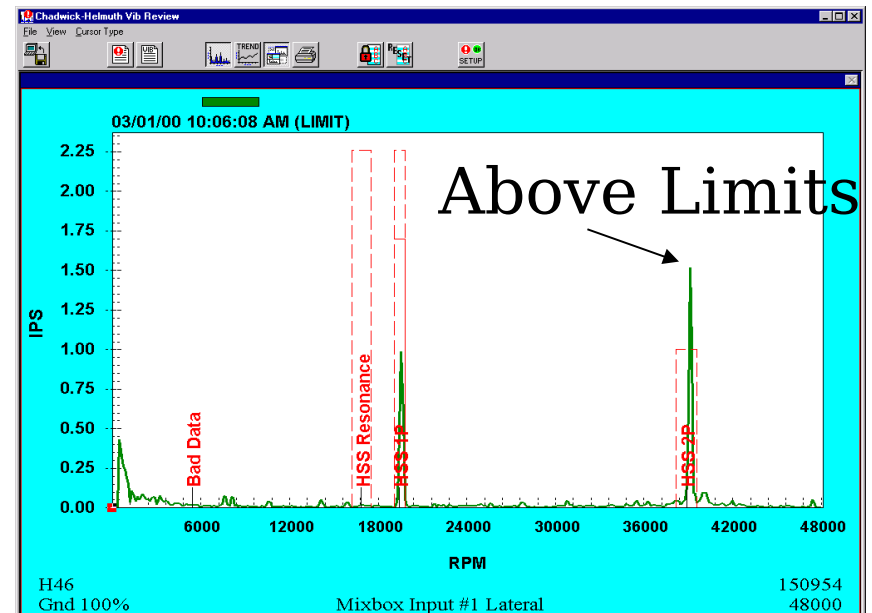
Eng Drive Shaft Catastrophic Failure

- Test of #1 & #2 Engine Drive Shafts indicated misalignment on Engine #1

- Maintenance performed and aircraft released to serviceability
- #2 Engine Drive shaft failed catastrophically in flight
- Equipment installed incorrectly
- Maintenance performed on incorrect shaft

- Human error allowed component to fly to failure
- Hardwiring would have prevented this error

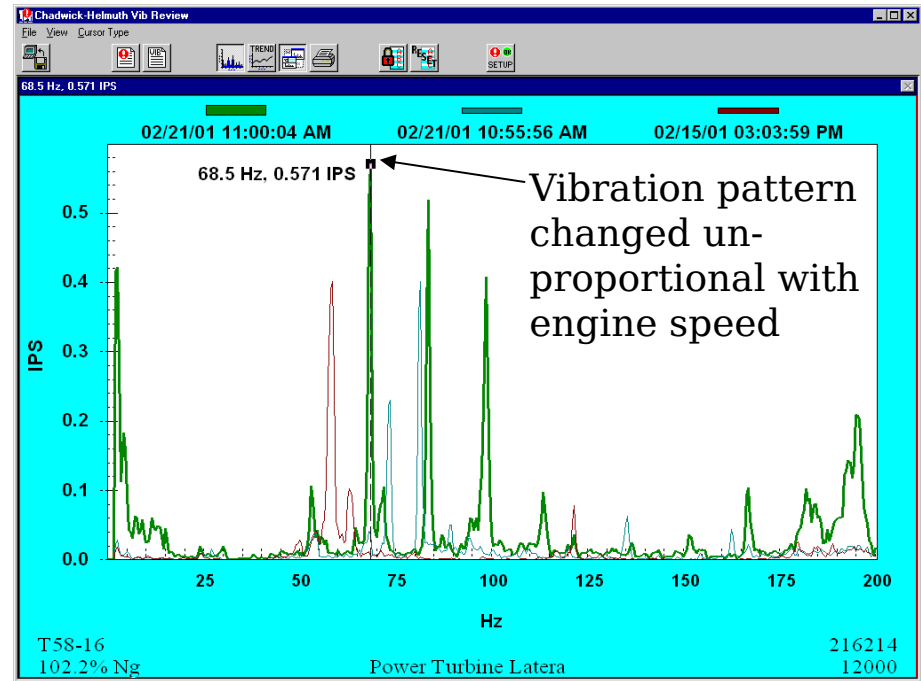
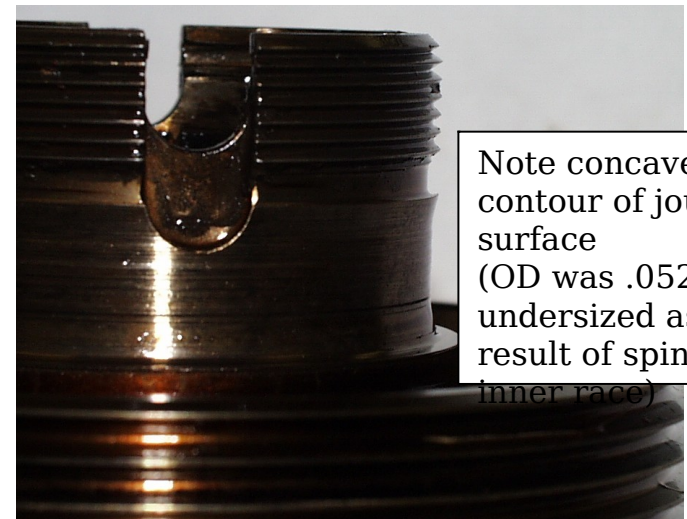
Substantial Finding - Impending Bearing Failure

- Engine passed test cell based upon Broadband vibration test
- Rejected on-wing due to audible howling

- Spectral analysis indicated Gas Generator Turbine as the problem area
- Troubleshooting with the spectral analysis concluded to non-synchronous behavior, indicating spinning bearing race
- Large fragments found upon teardown
- Test cell Broadband equipment not properly configured

- Early detection of bearing wear possible with spectral analysis, avoiding potential catastrophic failure on-wing

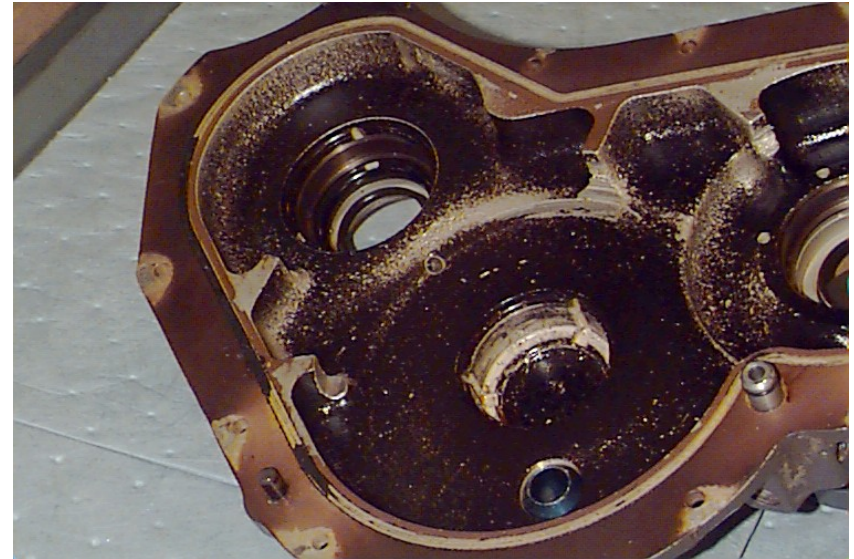
Aft Transmission Bearing Failure

- Aft Transmission Smoking in flight

- Bearing Failure
- Gearbox failed after bearing failure resulting in sheared lube pump shaft
- Loss of pump caused over temp in flight

- 100 Phase check was not performed
- Automated on-board system would have prevented this human induced error

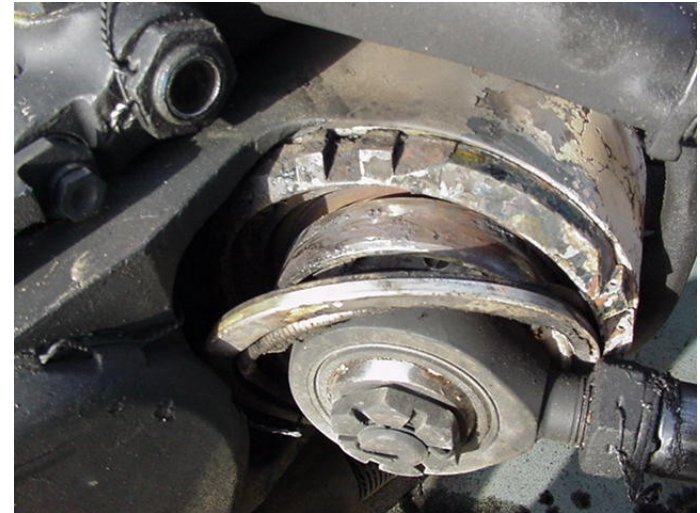
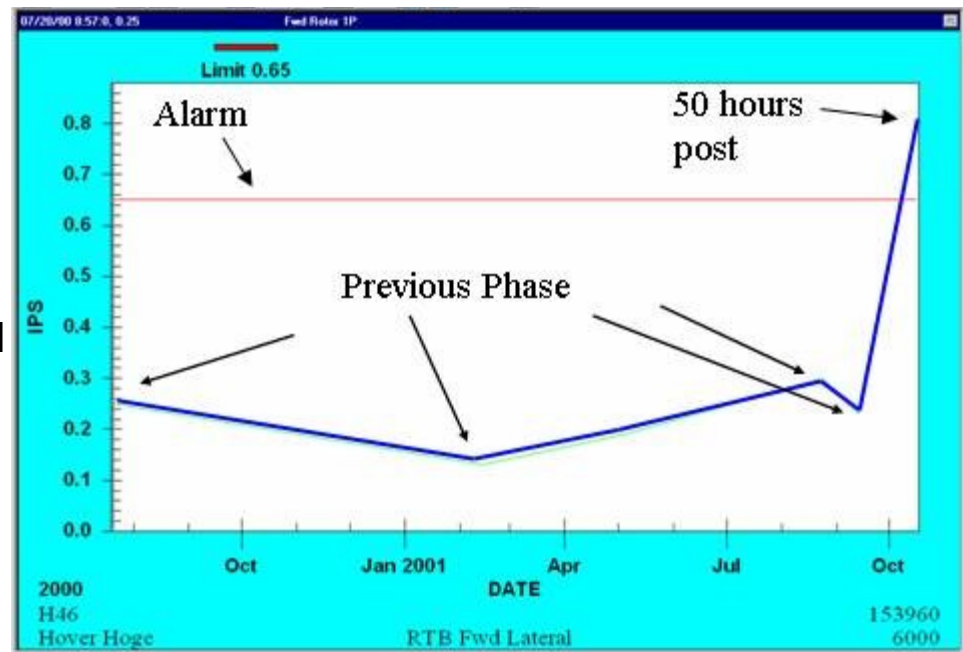
Head Bearing Failure

- Post Phase vibration checked and passed
- Significant increases in vibration reported by the crew after only a few hours of flight

- Repeated vibration checks verified the crew discrepancy
- Vib levels had risen over a short period of time
- Sr. Squadron officer instructed the aircraft to remain in service
- 7 hours later the flight was aborted by the Air Boss - aircraft significantly shaking on deck
- Failed head seal and bearing found
- Oil leakage problem was ignored
- Lack of lubrication led to failure
- Rotor head hub was close to total failure that would have resulted in a complete loss of the aircraft & crew

- On-board equipment would have indicated the problem immediately

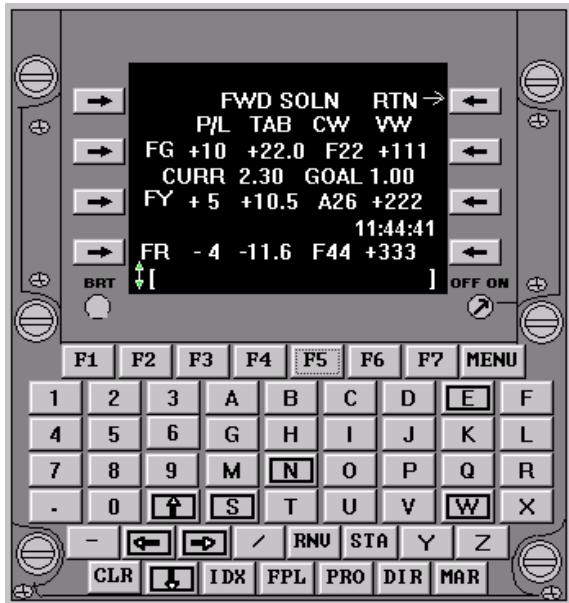
RT&B Displays

- Polar Plot Display
- Track Display
- Measurements & Solution Display
- Adjustments

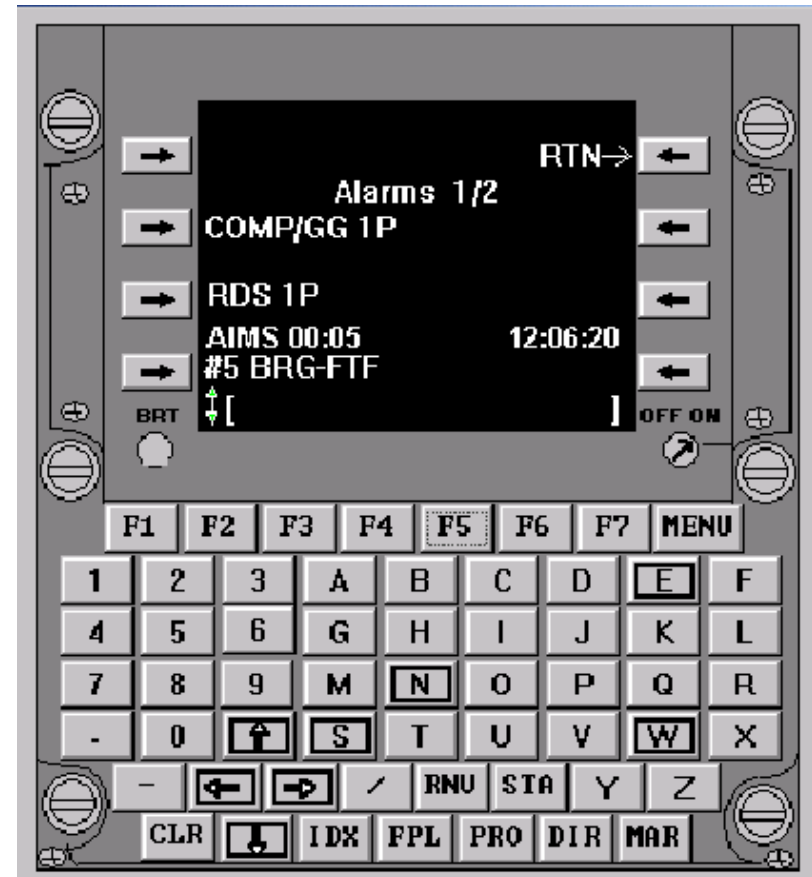
Improves Troubleshooting Capability

- **User definable configurations via Engineering Ground Station Software**
- **Multiple alarming levels, which drive visibility to aircrew**
 - Master Caution Panel
 - On CDNU Display
 - On AIMS Acquisition Unit
 - On Ground Station

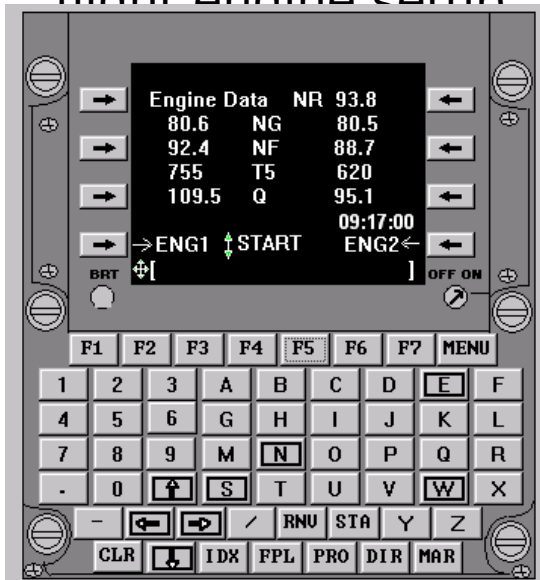
Engine Check Displays

- Engine performance assessed on-board, resulting in immediate feedback of acceptability
- Complete post maintenance check flight engine setup
